This is your Maintenance of Way Team update for April 12, 2015. Steam returned to the Sacramento Southern Railroad this week and your MOW Team was right there working to make sure the Granite Rock 10 would have a safe and smooth surface on which to run. So, let's get this update started before too much pressure builds up casing the pop-off valve to pop-off.

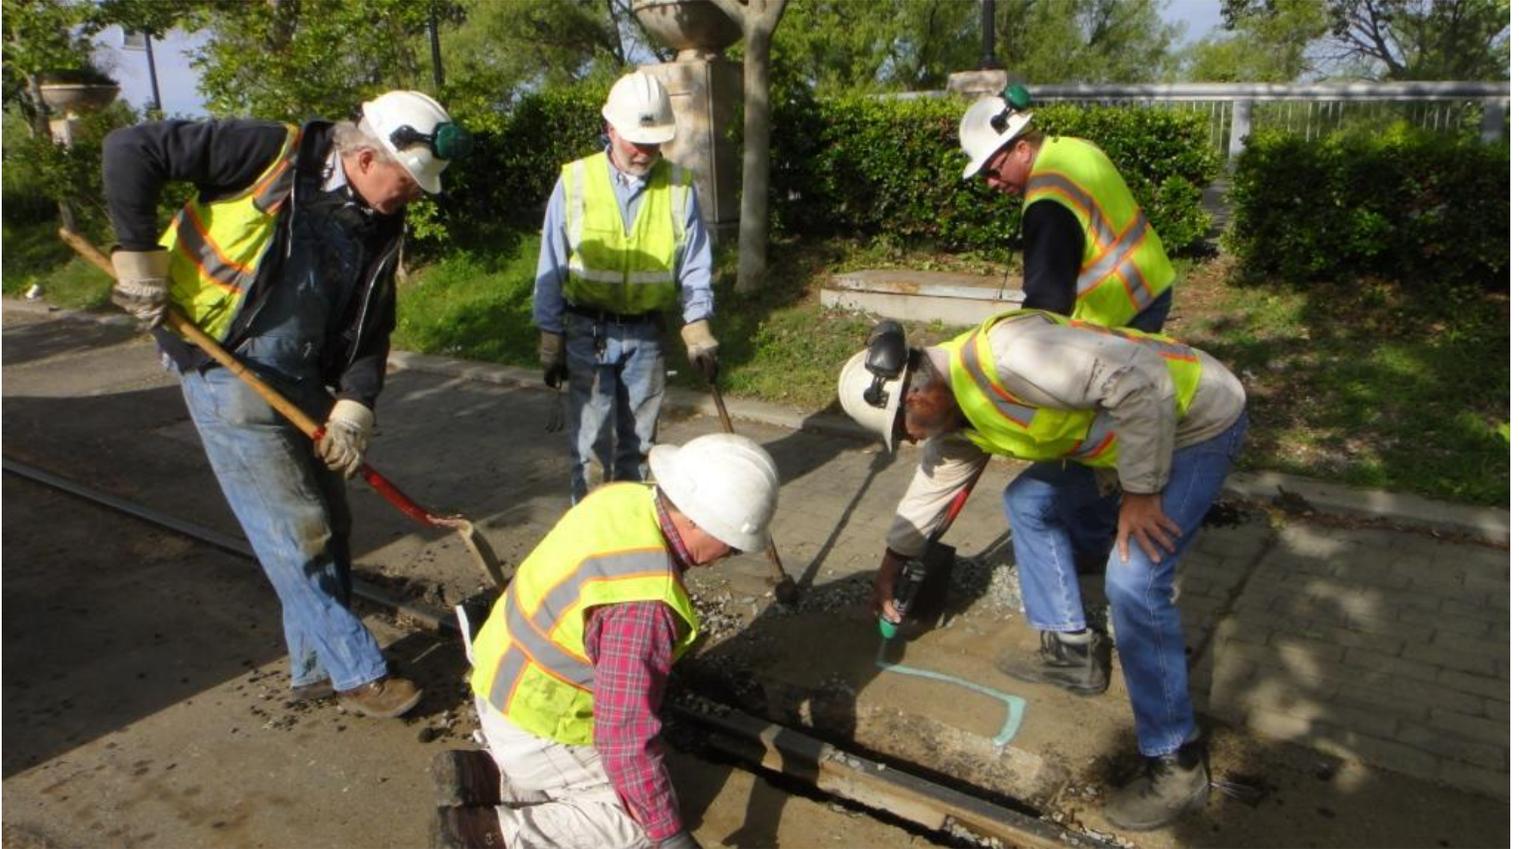
Steve, Mike M., Ed, Alan, and Mike H. begin work on digging out this troublesome joint

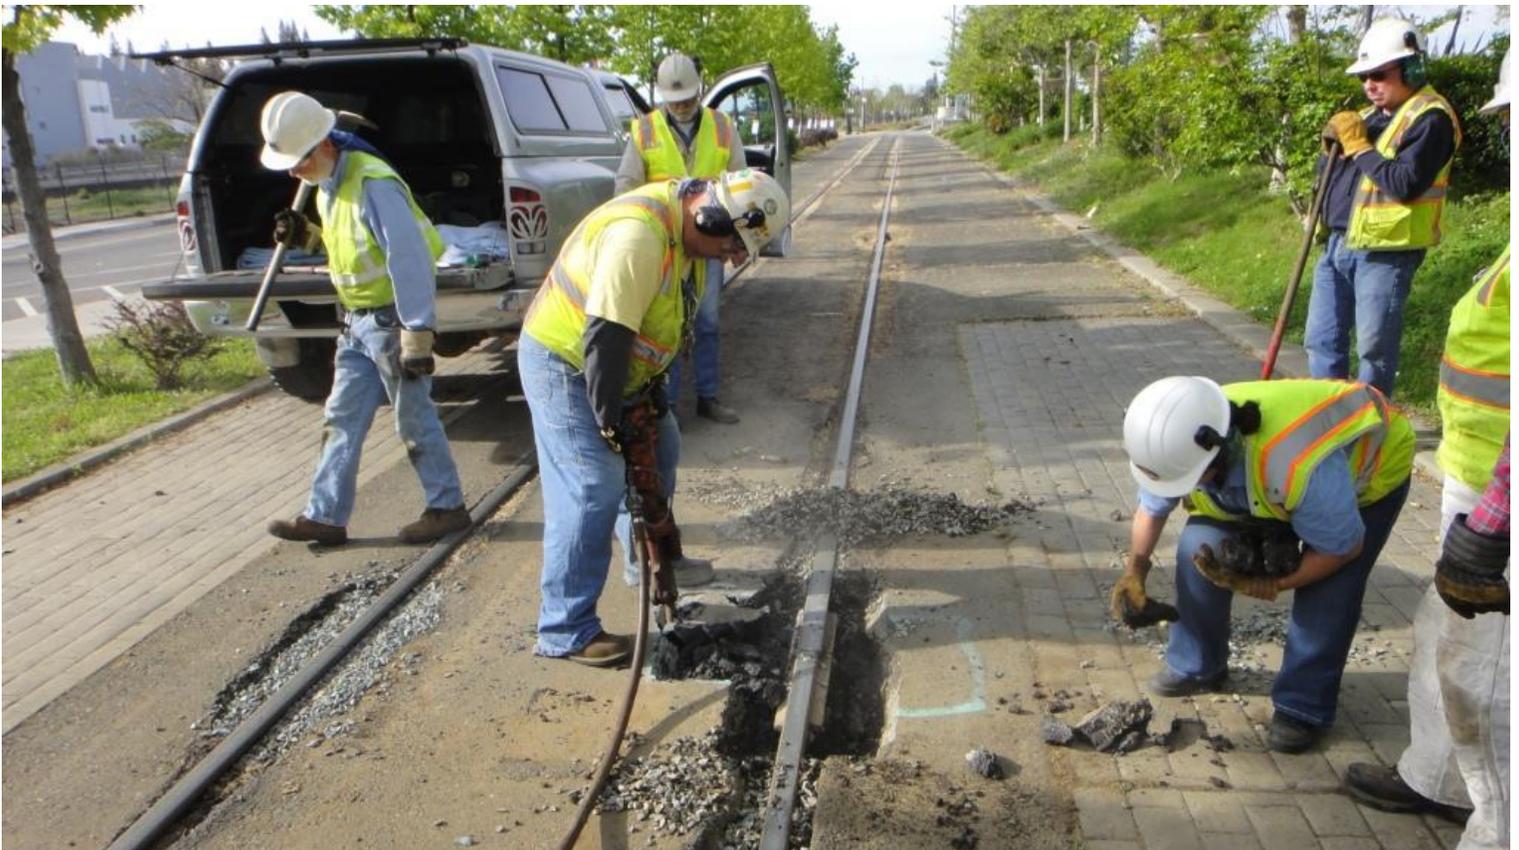
Pam picks-up asphalt debris as Mike F. with the jackhammer cuts around the joint

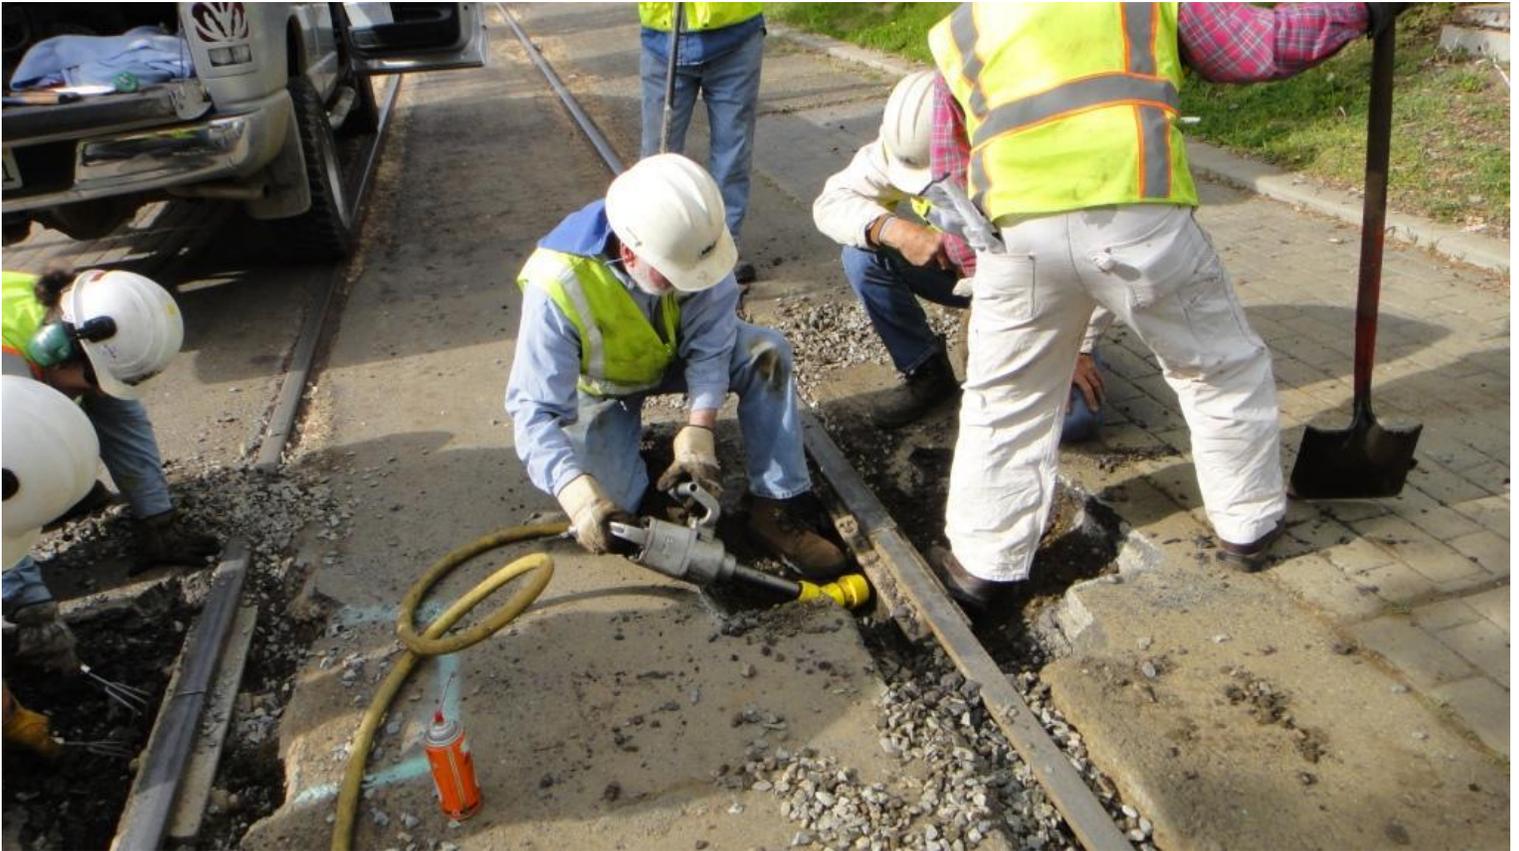
The impact wrench is brought in. Mike M. tries to get a grip on the nut while Mike H. holds the bolt in place with his foot

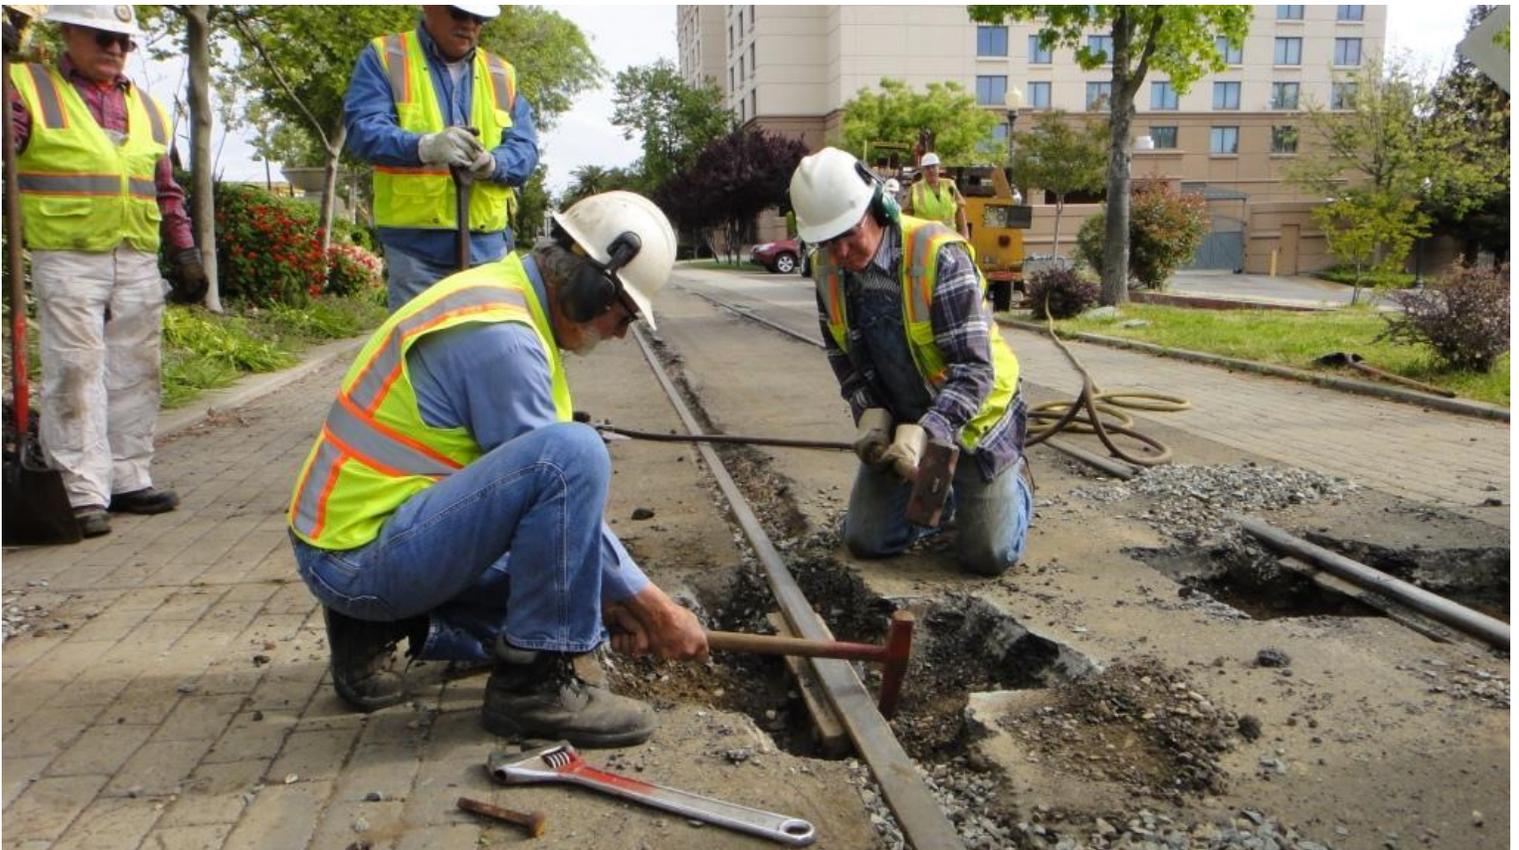
With the impact wrench striking out, Alan and Steve use a track chisel in a futile attempt to break the nut off the bolt

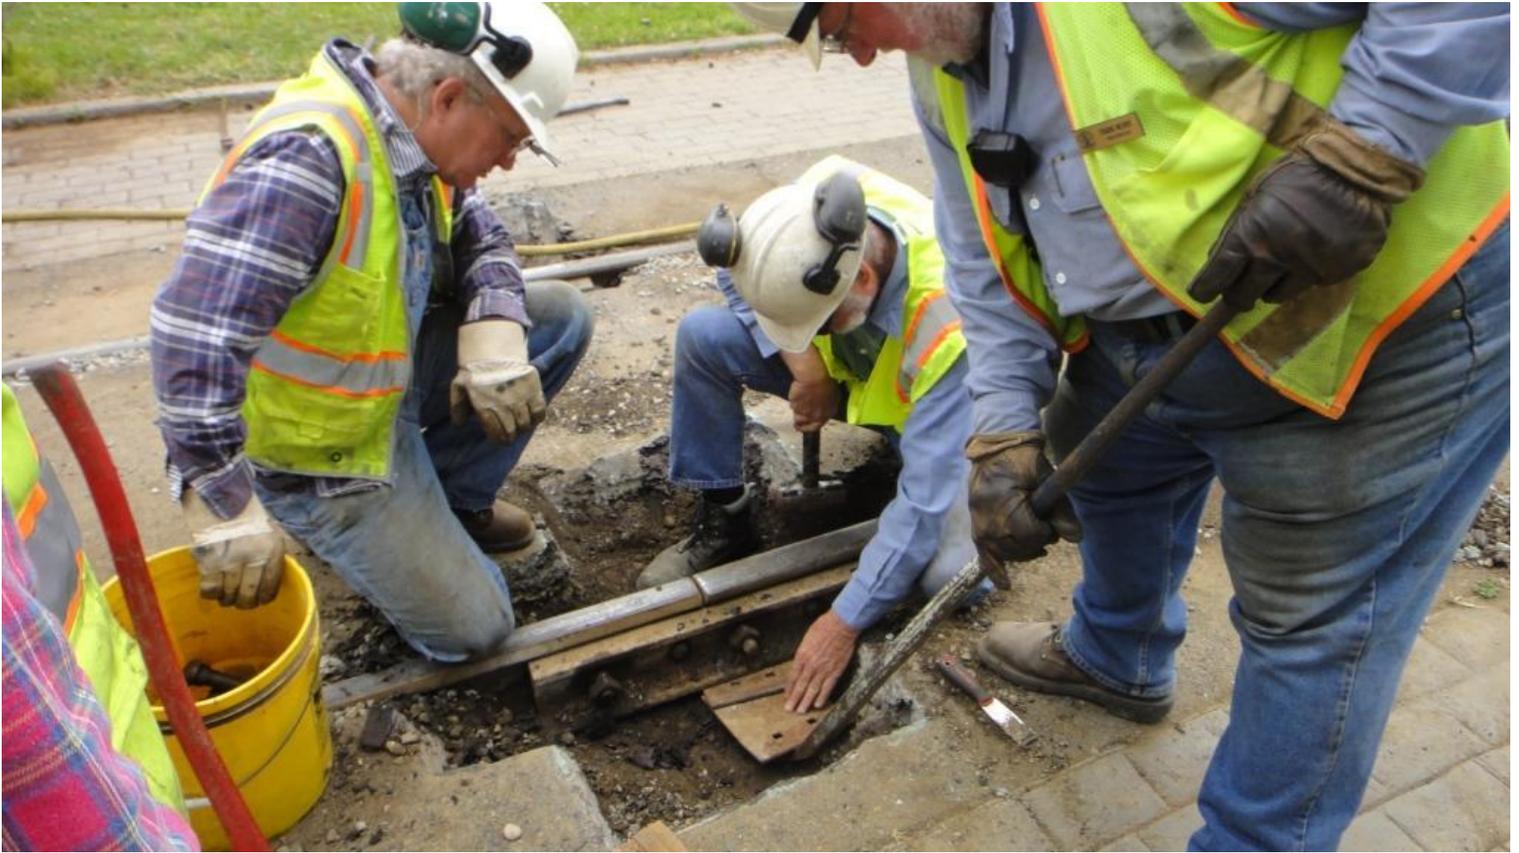
Steve, Alan, and Frank insert tie-plates between the base of the joint-bars and the sunken tie to add stability and support

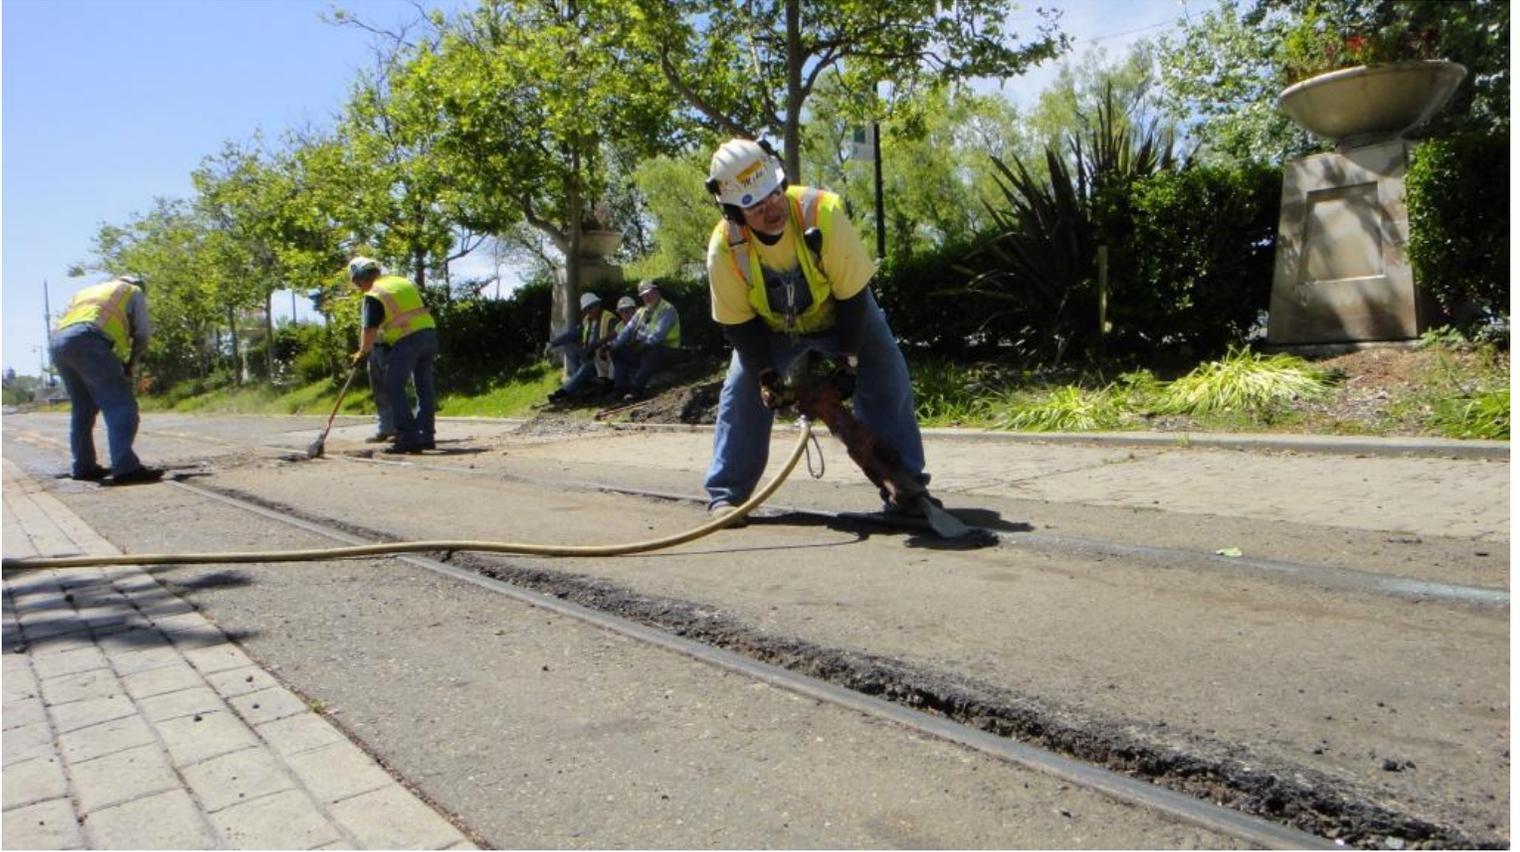
Mike F. uses the jackhammer to shave the buckling asphalt

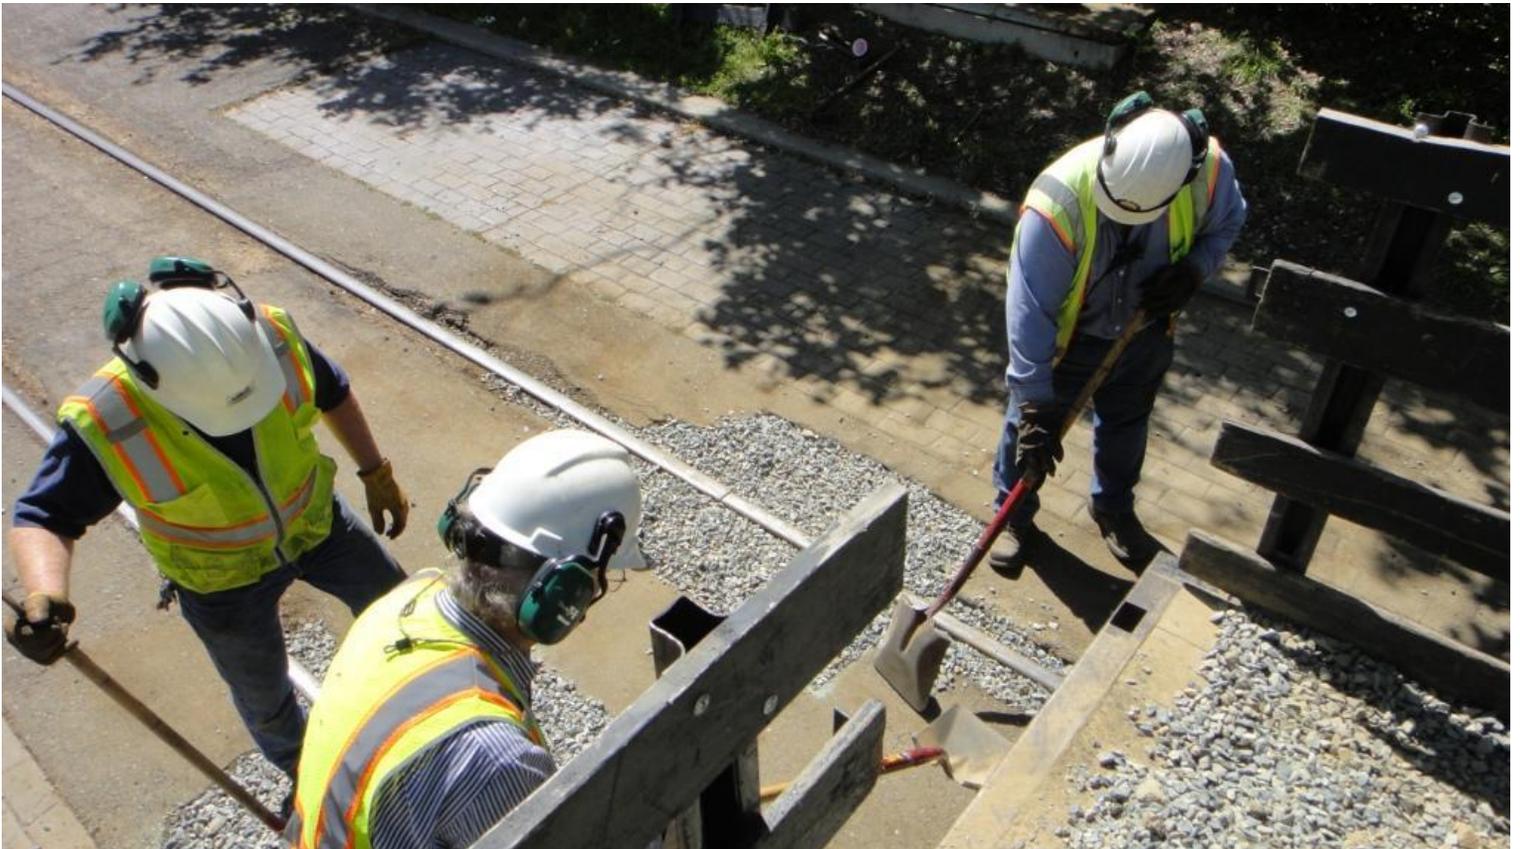
Filling in the holes, Ed, Steve, and Frank use crushed rock to fill in around the joint
